New York State Department of Transportation

Yellow Flag NB2228W025

Superseding Information:
This flag supersedes: YF NB2197W020

BIN: 1065318
Feature Carried: 278I278IX2M23027
Feature Crossed: 6TH AVENUE
Orientation: 8 - NORTHWEST
Region: 11 - NEW YORK CITY
County: KINGS
Political Unit: City of NEW YORK
Approximate Year Built: 1962
Posted Load Matches Inventory : Yes
Bridge Load Posting (Tons) : Not Posted for Load
Primary Owner: New York State Department of Transportation
Primary Maintenance Responsibility: 12 - State - Subcontracted to another Party
Typical or Main Span Type: 3 - Steel, 02 - Stringer/Multi-Beam or Girder
This Bridge is not a Ramp
Number of Spans: 322

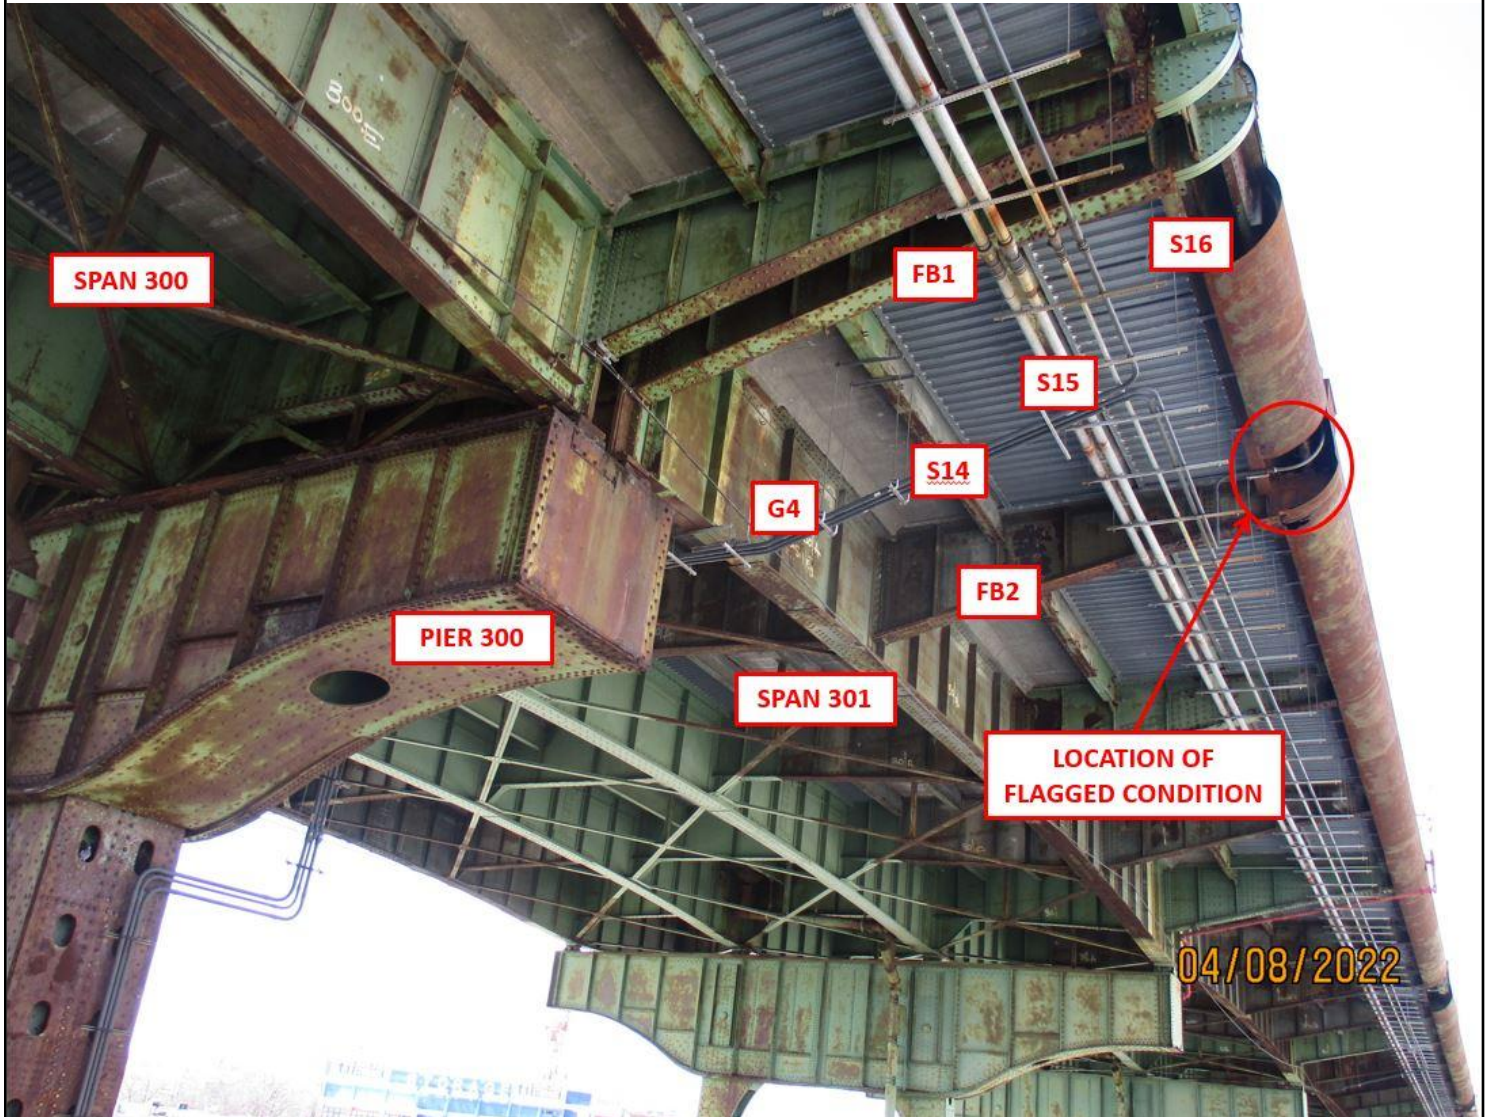
Photo Number: 1

Attachment Description: Span 301, General view of flagged location. Looking End Left.

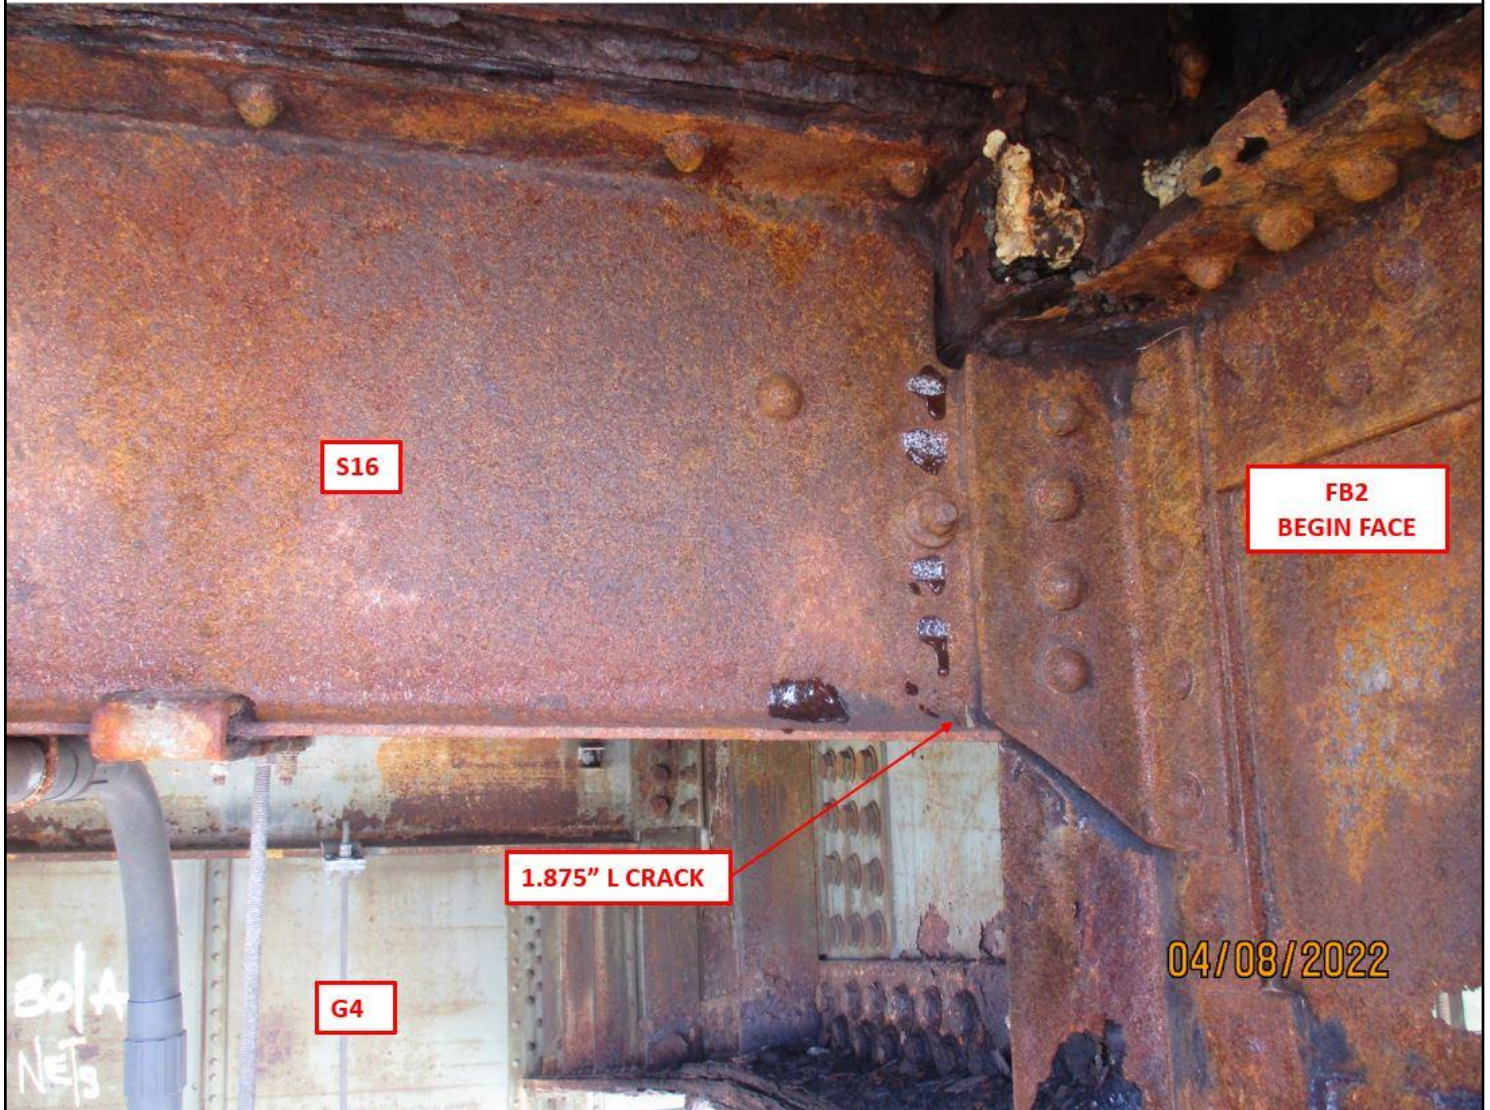
Photo Number: 2

Description: Stringer S16 at the connection to Floorbeam FB2 exhibits a 1.875" long crack (1.5" long vertically and 0.375" long horizontally) in the lower web at the connection angle. This crack is within a 14" long x 1.5" high area of the web that has up to 70% section loss. The full height web section loss along the connection angle is 26% (previously 24%).

Attachment Description: Span 301, Stringer S16 right face at begin side of Floorbeam FB2. Looking Left. Note: Stringer S16 has been blasted clean for a length of approximately 5' at the end.

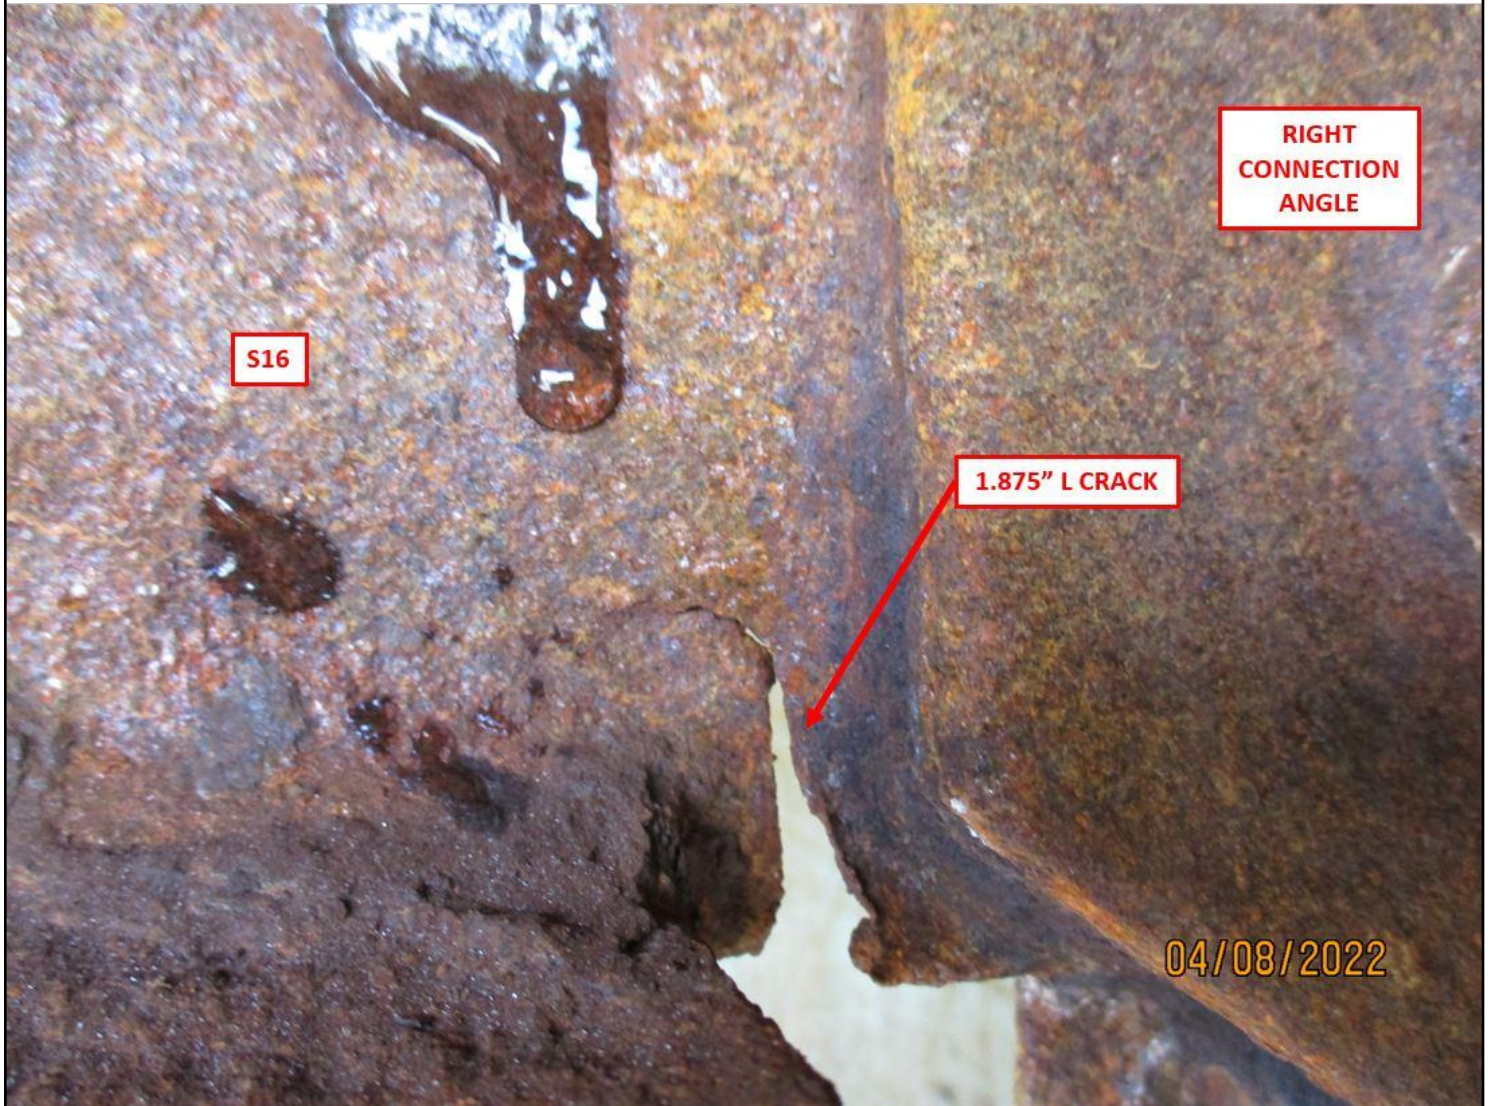
Photo Number: 3

Attachment Description: Span 301, Stringer S16 right face at begin side of Floorbeam FB2. Close-up view. Looking Left.

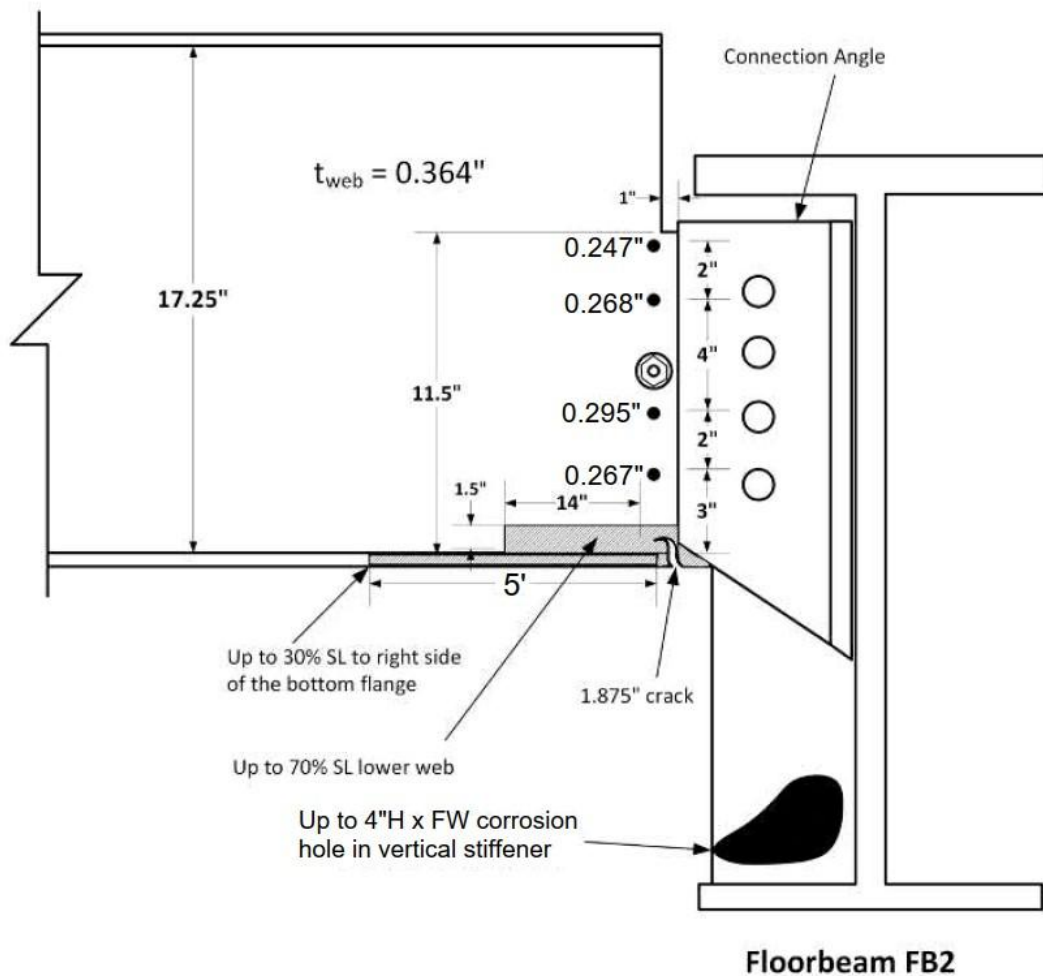
Photo Number: 4

Average remaining web section - $(0.267" + 0.295" + 0.268" + 0.247") / 4 = 0.269"$
 Web section loss - $(1 - (0.269 / 0.364)) \times 100\% = 26.1$ **Say 26%**

Span 301, Stringer S16 at Floorbeam FB2 begin side
(Looking left)

Attachment Description: Sketch of Stringer S16 at Floorbeam FB2

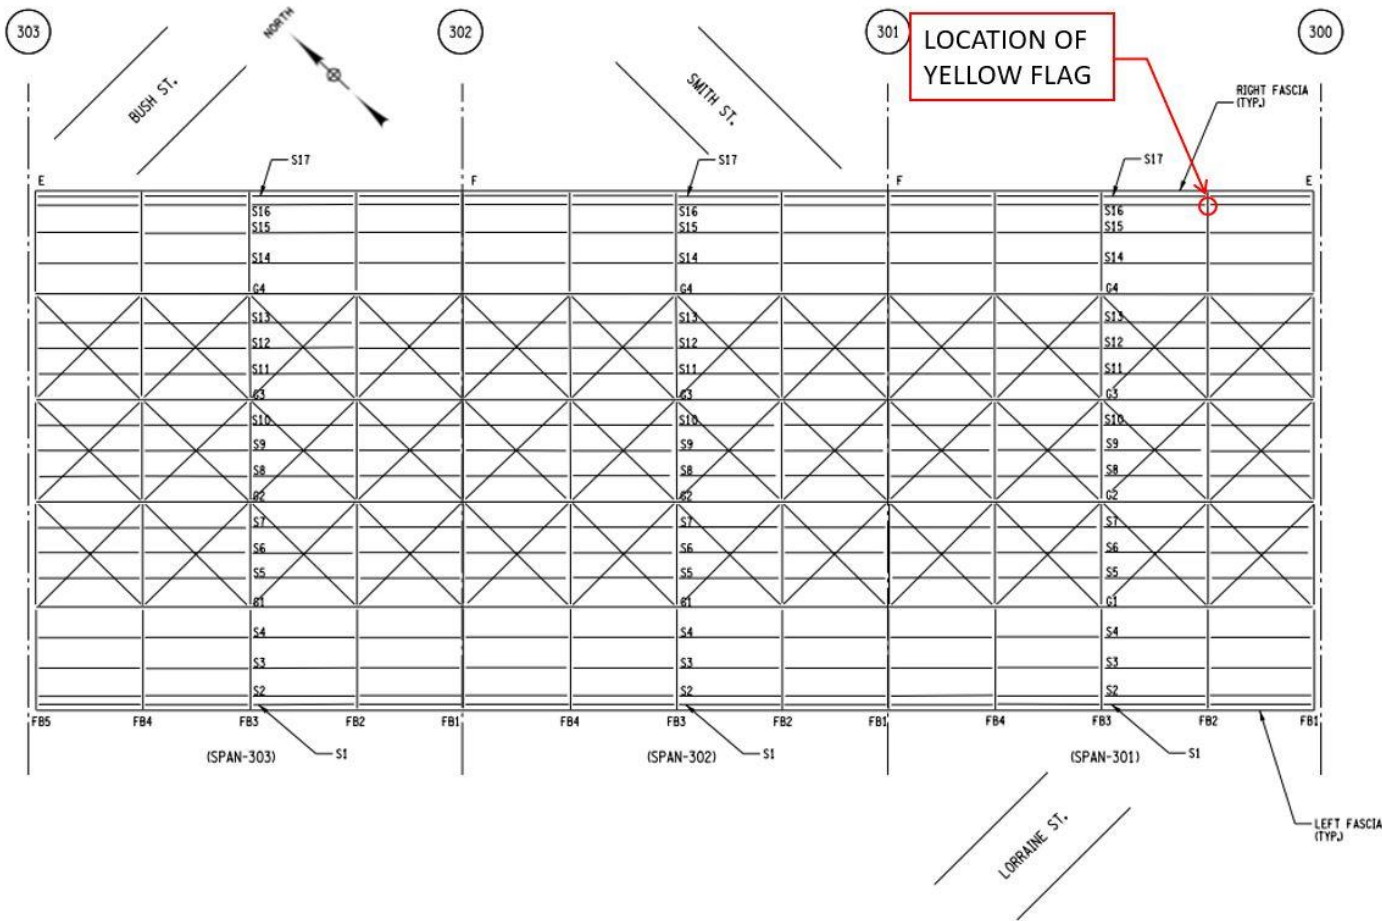
Photo Number: 5

Attachment Description: BIN 1065318, Framing Plan, Span 301
